## **Appendix C: Worst Performing Circuit Inspections**

### **Worst Performing Circuit Inspections:**

### **Staff Observations – Monday June 13, 2005**

ComEd Chicago Region

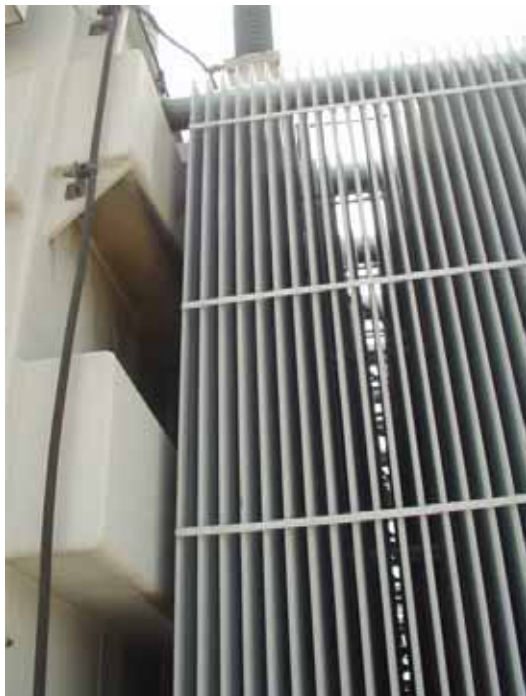
P6280138 – XFMR73 possible slow leak from top flange and down side

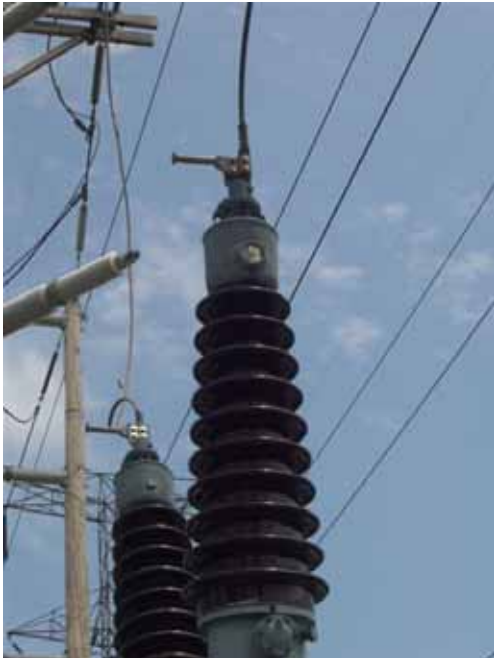
P6280141 – L14310 OCG 138KV BREAKER – C phase bushing oil level gauge glass broken – ComEd personnel know about it and are waiting for the next planned outage to correct

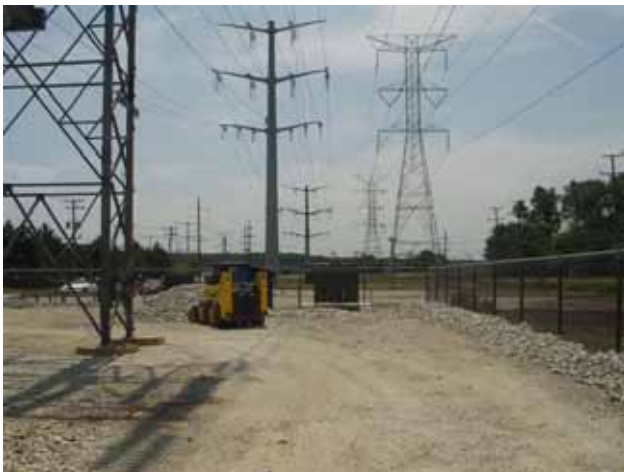
P6280147 – New gravel being put in place around fence – noted that ground in station has “smoothed out” in many places.

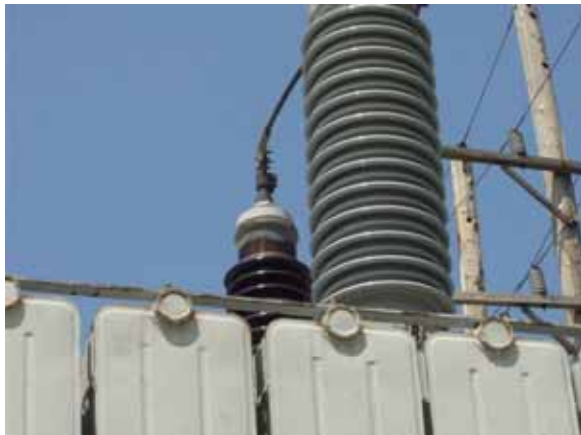
P6280158 – paint on top of XFMR B phase bushing covering glass indicator for oil level – ComEd noted that the oil level can still be seen and the glass was only partially covered by paint.

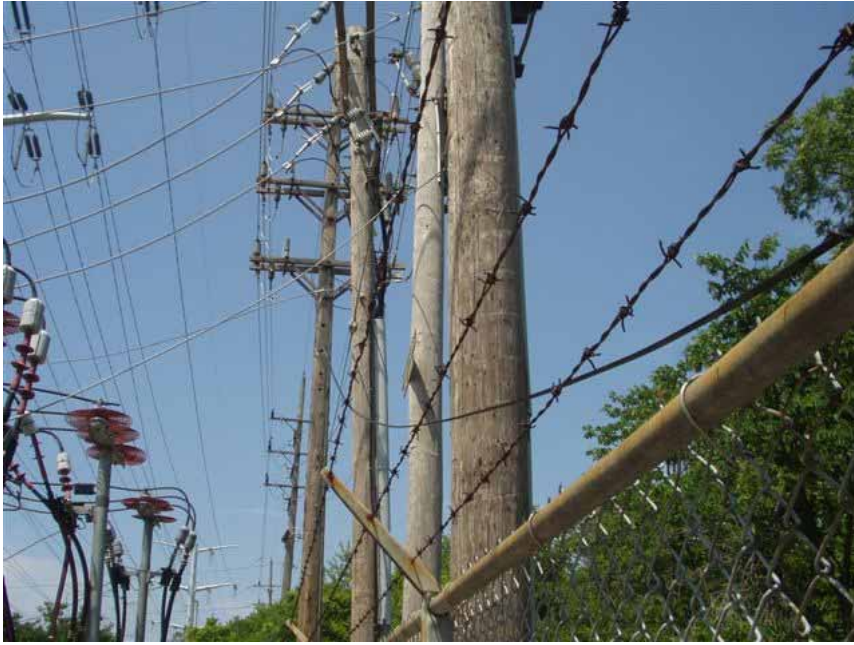
P6280160 – phone line loosely draped across poles and along substation fencing

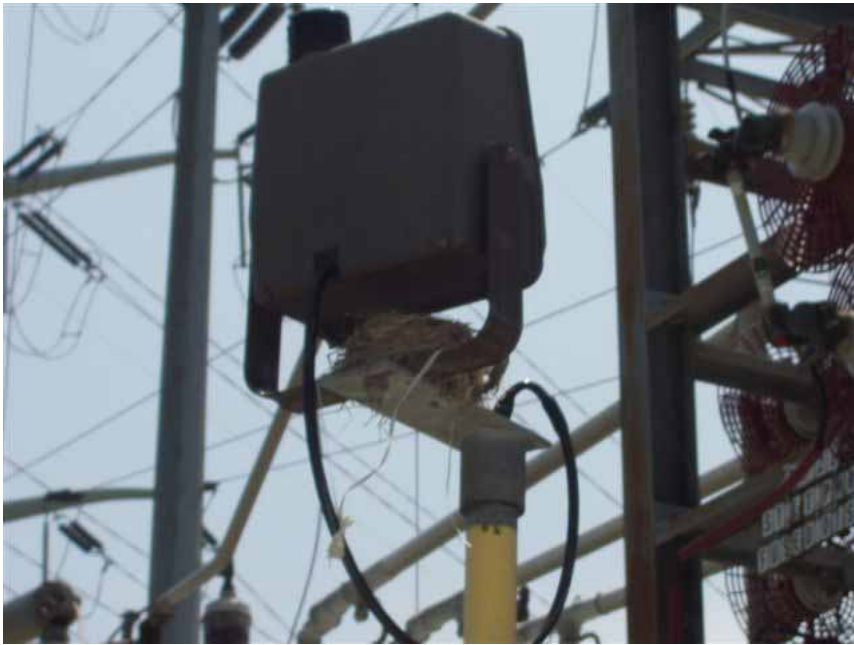
P6280162 – birds nest in framework for light in substation

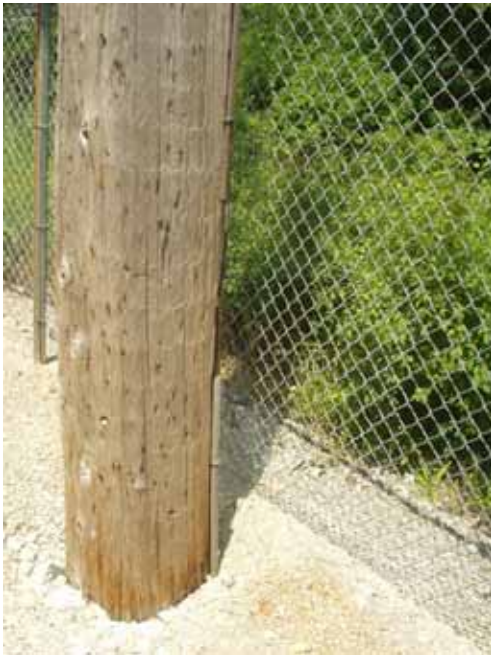
P6280165 – broken/missing cover/molding on ground wire on pole. Usually see this in rural areas where tractors may have hit the pole and knocked off the cover but inside a substation and next to the fence not sure how this would occur

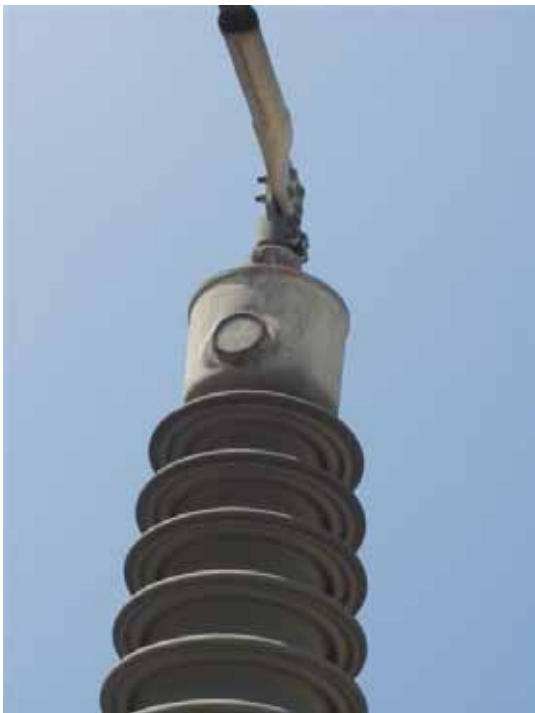
P6280171 – 138KV BT 1-2 OCB A phase bushing oil near/at H – glass cracked

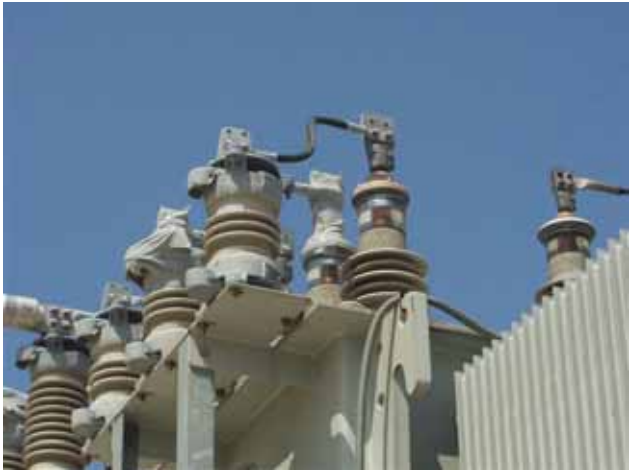
P6280174 – XFMR77 tape cover top part of window for oil level – ComEd noted that the oil level can still be seen.

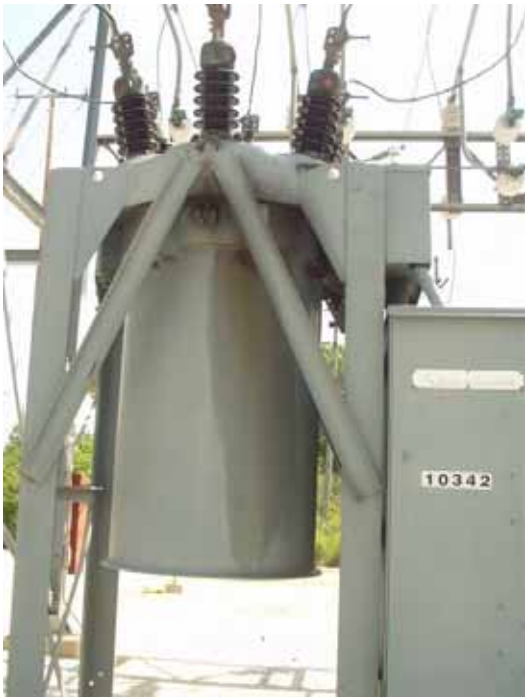
P6280180 – 34KV10342 – oil leak on tank

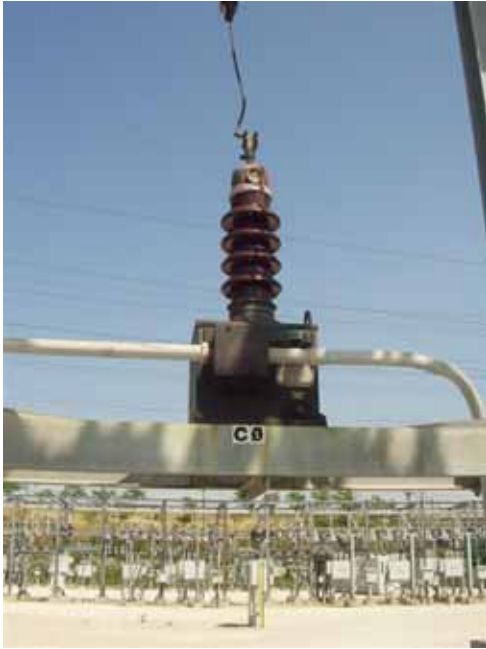
P6280181 – Bus 2 pots c phase cracked indicator window

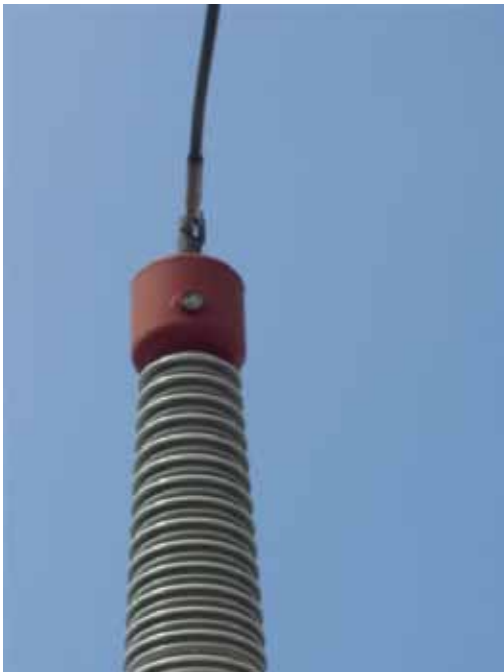
P6280185 – 345KV BT1-2 – A phase bushing looks high  
B phase bushing looks high on other side  
C phase bushing looks high on other side
